MiLyn, LLC

# **Certified Test Reports**

**The Insulation Properties  
of TruProtect™ in:**

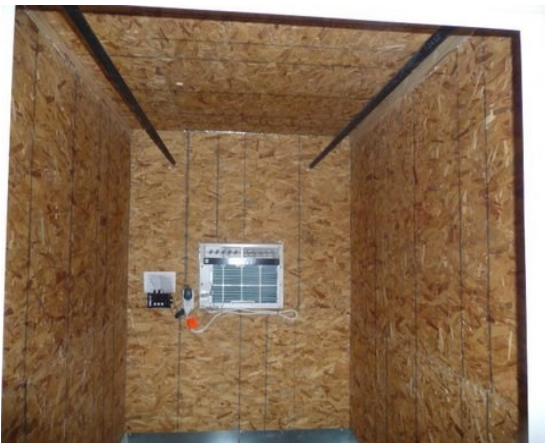
**The mockup unit measured 8' x 8' x 6' with 2"x4" framed stud walls. The walls were lined with the standard R-13 insulation. The outer and inner layers were standard half-inch OSB. Workers added a refrigeration unit and ran a 44 hour monitored test. Afterward they lined the mockup refrigerator with TruProtect.**

There is no established test protocol for measuring the insulation effectiveness of walk-in freezer and refrigerator units. TruProtect mocked up such a unit in its factory under the direction of someone experienced in this field. The goals were to test how much TruProtect might reduce energy consumption, and to determine how it might help to maintain a stable temperature. Fluctuations of temperature can occur even with thermostatic control. These variations can destabilize food and start the spoilage process.

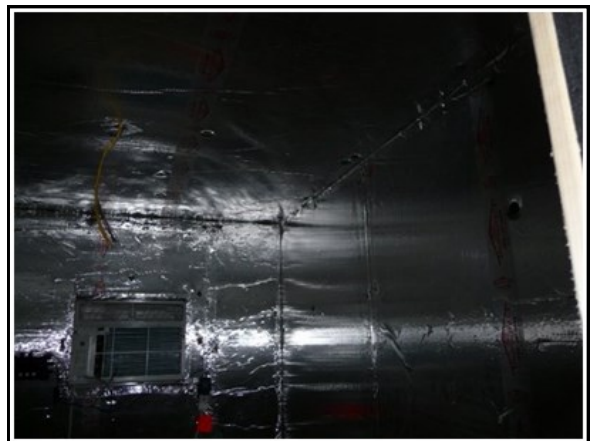
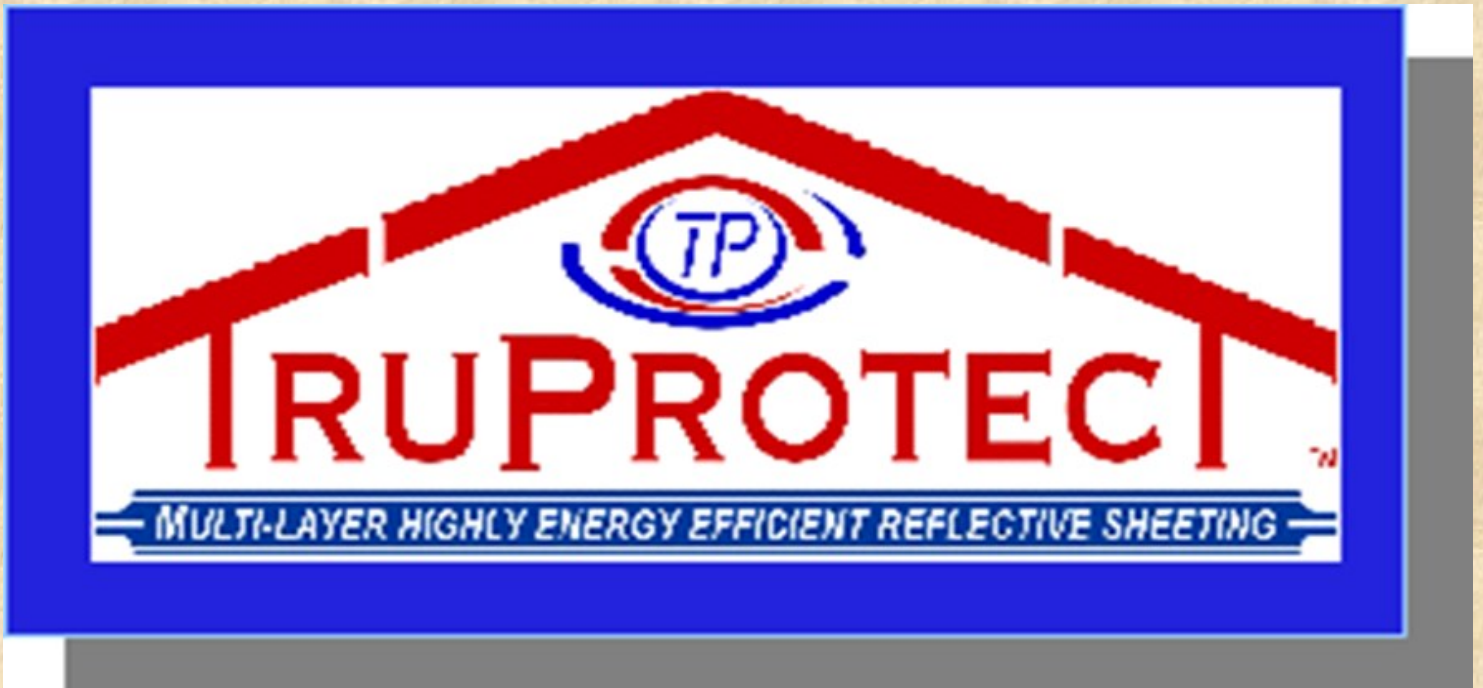
Set Temperature	Time	Date	Cooler temp	Warehouse Temp	Outside temp	KWH power reading
<b>WITHOUT TRUProtect</b>						
45	2:00 PM	30 Aug	44	89	89	663
45	8PM		42	91	90	665
45	8:00 AM	31 Aug	42	82	70	667
45	11:45 AM		39	88	83	669
45	3:15 PM		44	91	87	671
45	8AM	1 Sep	40	88	68	672
45	10AM		39	78	74	674
Total run time 44 hours using 11 KWH or .25 KWH per hour run time						
<b>With 1/2" TruProtect installed on all 6 coils</b>						
45	3:00 PM	1 Sep	47	95	93	674
45	8:00 AM	2 Sep	45	79	66	674
45	11:30 AM		45	88	81	674
45	3:15 PM		45	89	95	674
45	8:00 AM	3-Sep	45	77	62	674
45	11:00 AM		45	81	67	675
Total run time is 44 hours using 1 KWH or .023 KW per hour run time

**The initial 44-hour test with the standard design established baselines both for energy usage and temperature fluctuation.**

**With TruProtect now lining the unit, the factory ran a second 44-hour monitored test.**
